TRANSPORTATION SAFETY

# REFLEXIONS

Issue 21 – March 2004

## Special Issue on Fishing Vessels

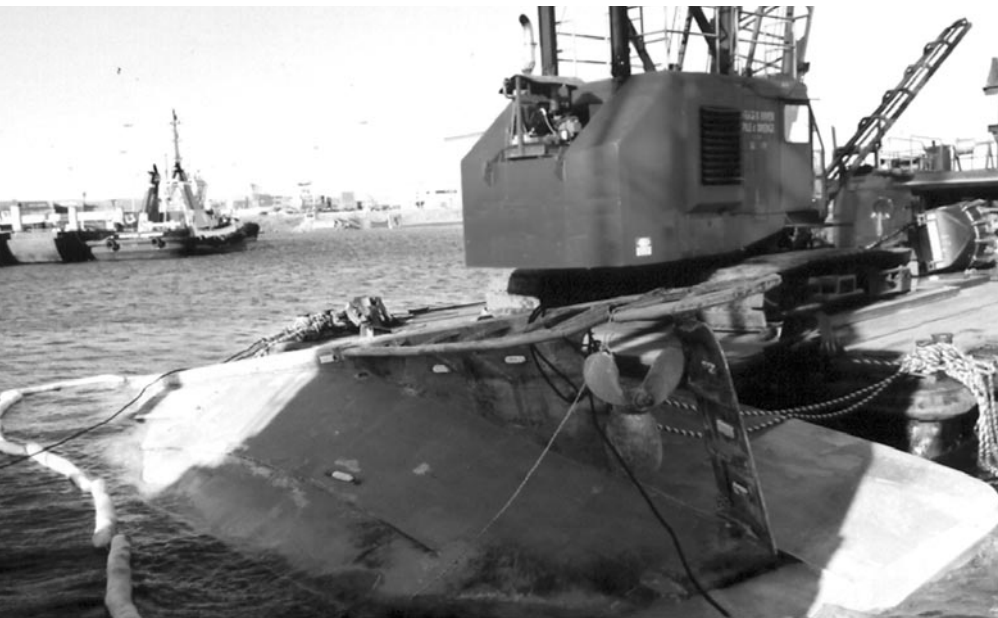
**Cap Rouge II alongside salvage barge**

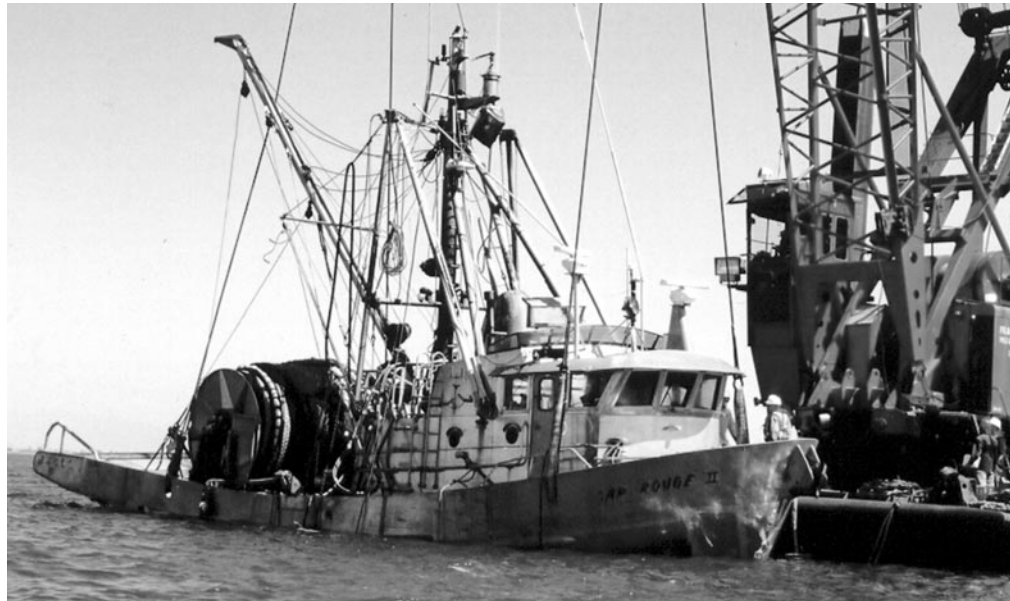
**Cap Rouge II raised upright at the time of salvage**

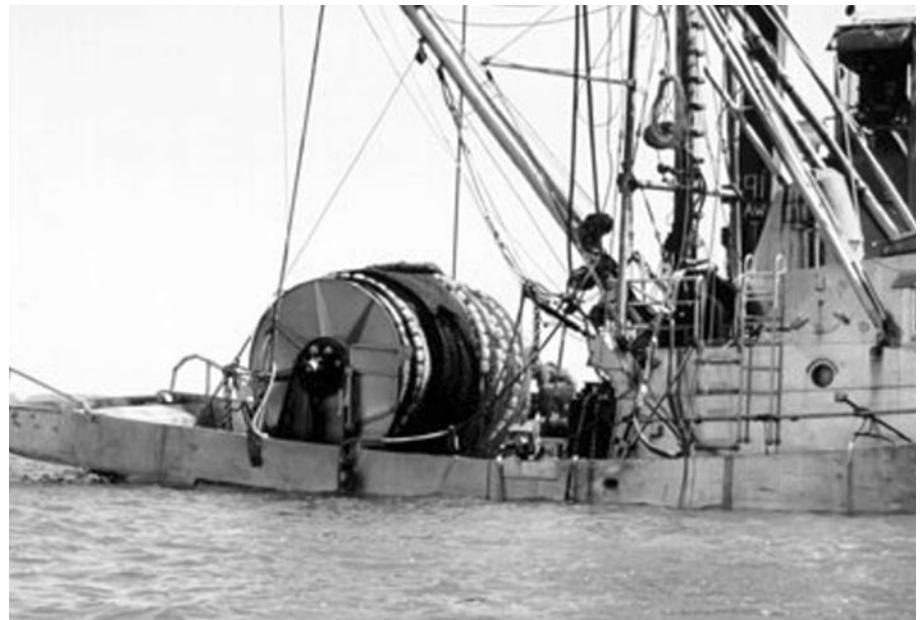
In this instance, a larger seine net was being employed, the weight of which was not verified until after the capsizing, when it was found to be some 7.4 tonnes. This weight was somewhat heavier than the seine net usually carried, which weighed approximately 4.5 tonnes. The nets were routinely stowed on the power drum, located 1.75 m (5.67 ft) above the main deck, where their weight effectively raised the position of the vessel's centre of gravity.

**Working deck of *Cap Rouge II* showing west coast salmon seine net wrapped on net drum**

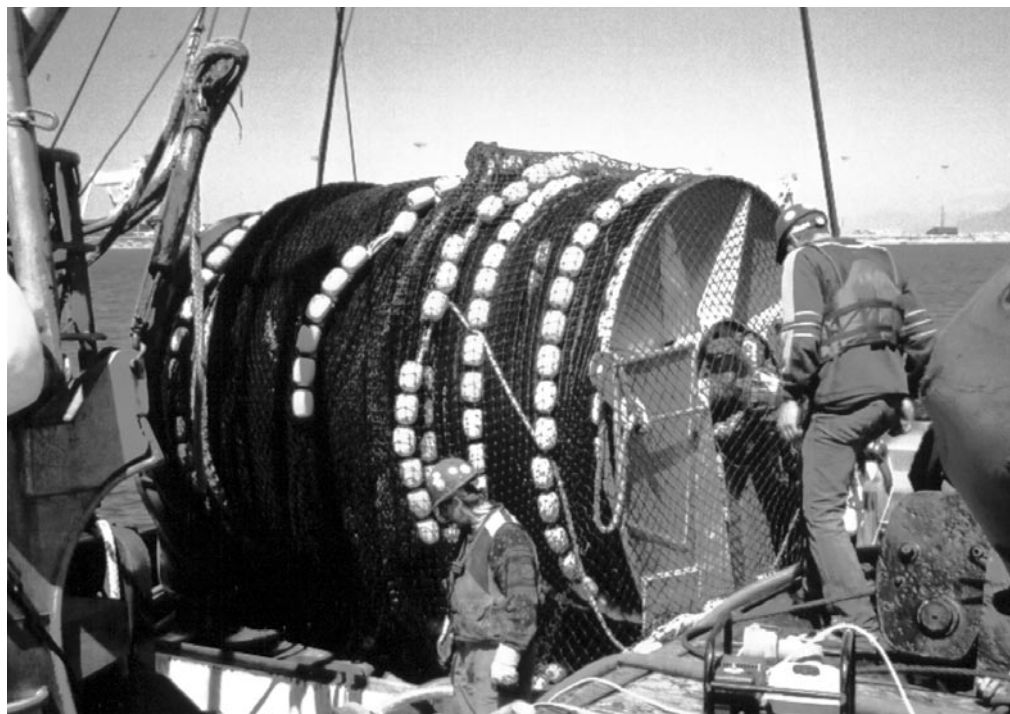
**Close-up view of seine net on the net drum**

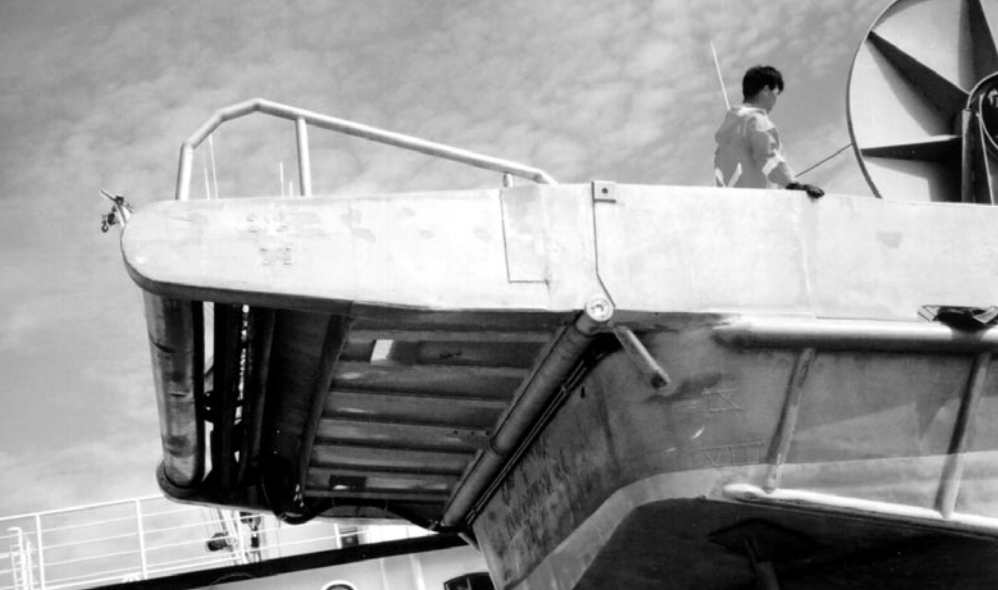
**Stern of Cap Rouge II showing solidly constructed stern ramp extending beyond the transom**

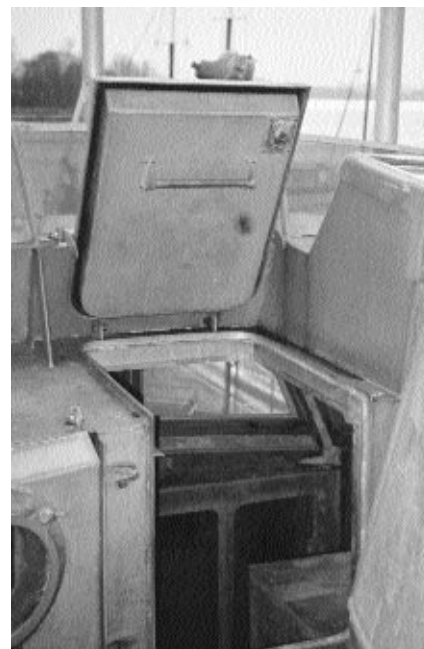
**A combined hinged hatch cover and door on the centreline at the after end of the wheelhouse**

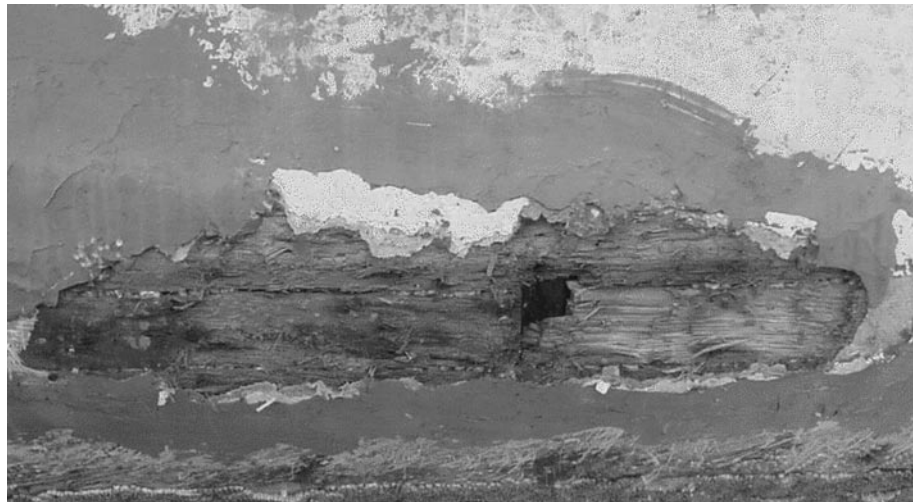
Examination of the vessel revealed substantial wear on the hull in way of the lazarette. These patches of excessive wear were in way of the drag hoist pulleys that were mounted on the stern A-frame. The fibreglass coating was worn through, and there were deep gouges in the wood planking. There was a hole, approximately 10 cm in diameter, in the wood planking on the port side. The scallop

**Damage, port side**

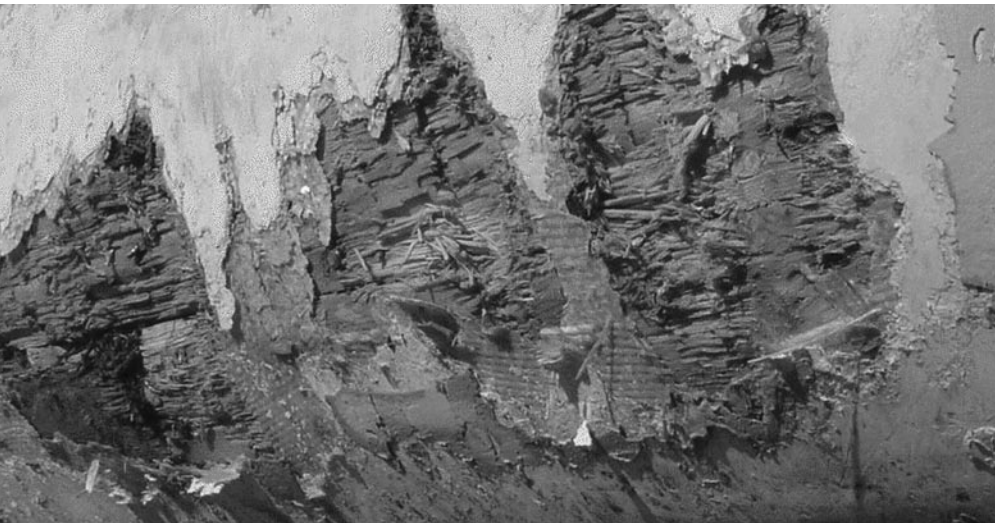
### Damage, starboard side

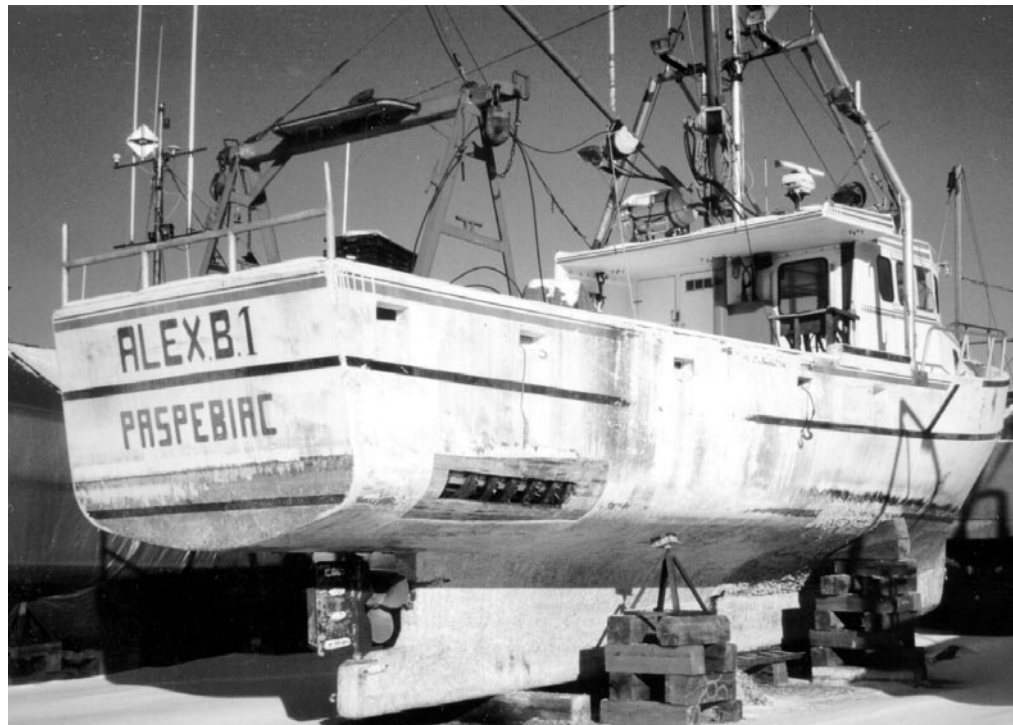
Location of damage on starboard side

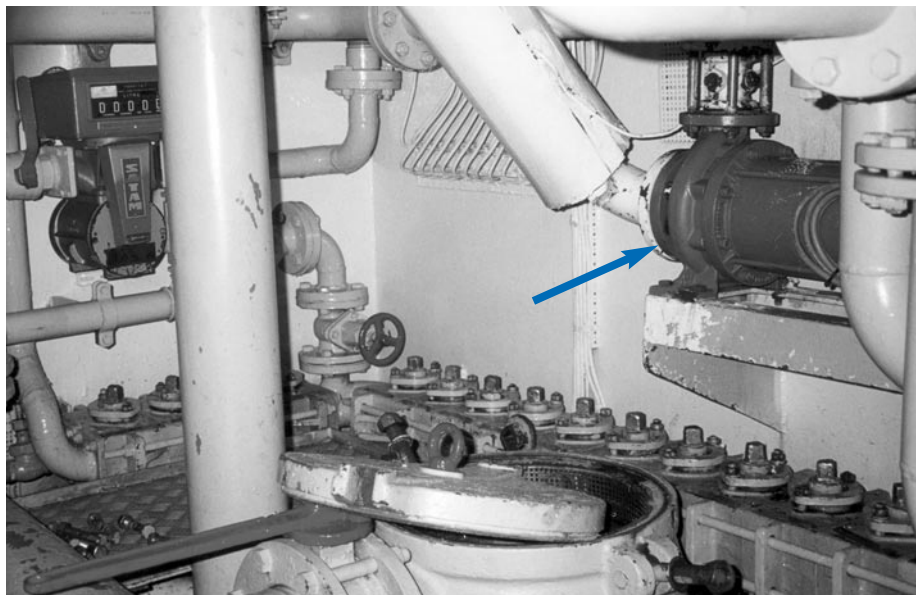
At the time of the occurrence, the vessel's main and auxiliary electrical power was being provided by a shaft alternator powered by the main engine. In the event, the expanded refrigerant acted as an asphyxiant, causing the suffocation of the main engine by displacing oxygen within the engine room. When the main engine shut down, all main as well as auxiliary electrical power was lost.

### Port liquid refrigerant pump

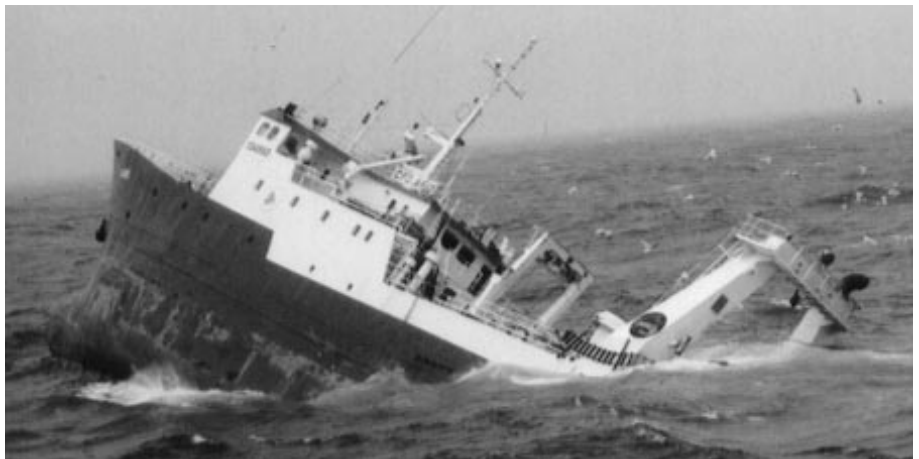
**Fame, pronounced list**

As the weather deteriorated, the vessel rolled more due to the increasing seas and was heeled by the wind force, causing all of the existing loose water on the factory deck to gravitate to starboard. The water also flowed toward the after end of the deck because the partially loaded vessel was already trimmed slightly by the stern. The initial slight ingress of water through the partially obstructed starboard-side discharge valves increased when they were more deeply submerged as the immobile and wind-heeled vessel rolled to starboard. The weight and free-surface effects of seawater accumulating on the starboard side of the factory deck increased the angle of heel and reduced the remaining righting ability of the vessel on that side.

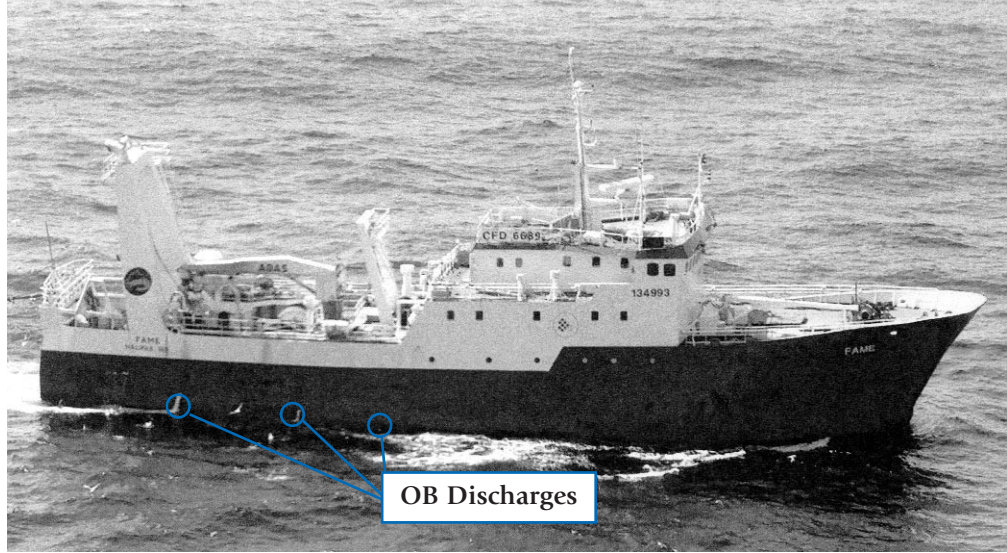
or any other structural hull failure affecting the watertight integrity of the vessel, the most likely source of the ingress of seawater onto the factory deck was through one or more of the overboard discharge valves in the starboard side shell plating of the factory tween-deck.

After pumping power was lost, it is likely that entrained discarded fish material and other waste debris remaining in the piping system, settled and became lodged in the non-return discharge valves, causing them to malfunction. The absence of anti-syphon loops in the pump discharge piping inboard of the shipside valves, would have also contributed to the ingress of seawater through the valves onto the factory deck.

## Overboard discharge valves

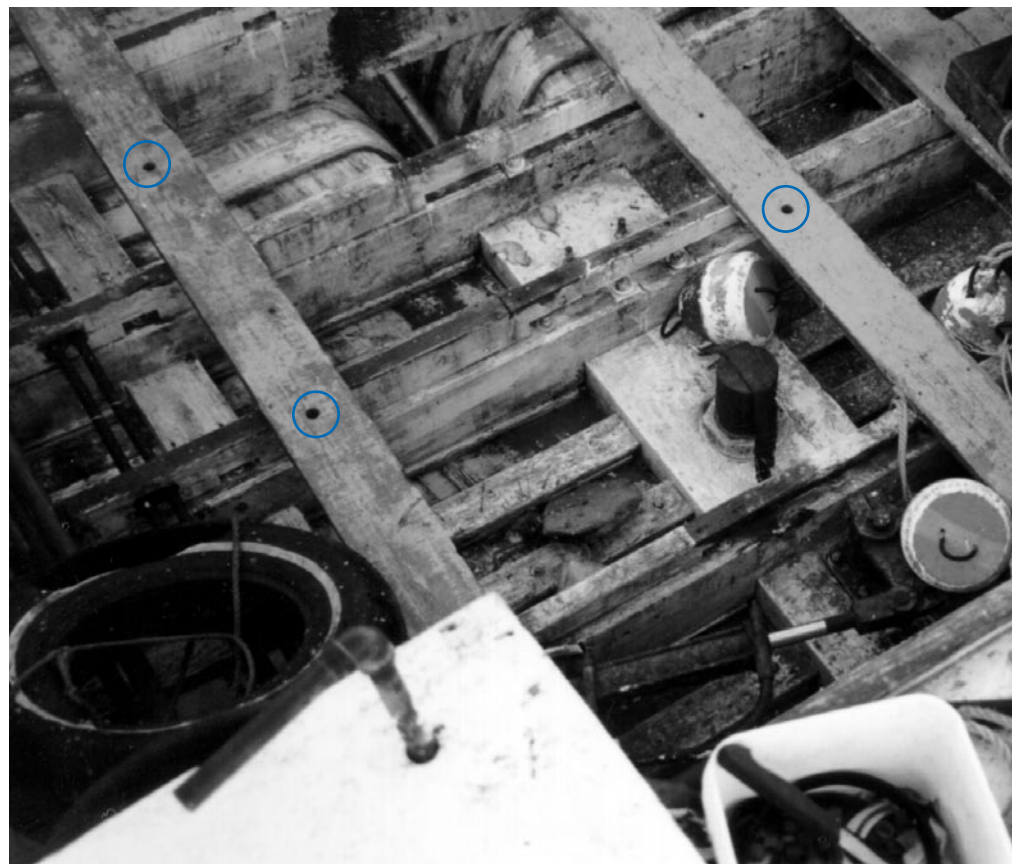
Drain holes in deck

During the occurrence, with a dense load of herring on deck, the fish covered the small and widely spaced drain holes, which prevented a large quantity of shipped seawater from getting down to the bilges, where it could be pumped out.

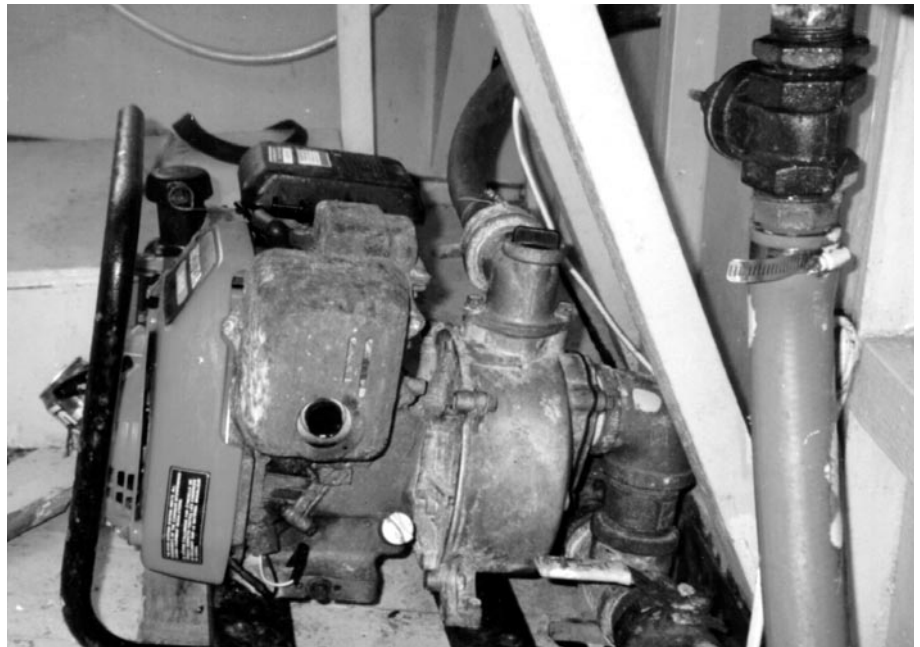
The Board also noted in this report that the gasoline-powered pump in the wheelhouse was a Honda model WN20. The pump's gasoline engine exhausts directly into the wheelhouse, where fuelling of the unit by hand also takes place. This poses a

risk of asphyxiating the operator conning the vessel and/or causing a fire within the compartment. Honda portable pumps have given rise to safety issues in the past. Due to their dissimilar metal components and galvanic corrosion problems, these pumps are not recommended for use with sea water. A Ship Safety Bulletin (SSB 98-04) was issued by TC relating to the suitability of portable pumping equipment for the marine environment. The owner/operator of the *Alain-Josée* reported having heard of Ship Safety Bulletins, but had never received one.

**Gasoline-powered pump**

**Honda portable pumps are not recommended for use with sea water.**
